SPECIAL REPORT ON ANADROMOUS STREAM SURVEYS OF CLEVELAND
PENINSULA, INCLUDING EMERALD BAY, VIXEN INLET, UNION BAY,
CLARENCE STRAIT, BOND BAY, SPACIOUS BAY, AND PORTIONS OF
PORT STEWART AND HELM BAY

Subdistricts 107-10 and 102-80

March 1985

Alaska Department of Fish and Game
Division of Commercial Fisheries
Petersburg, Alaska

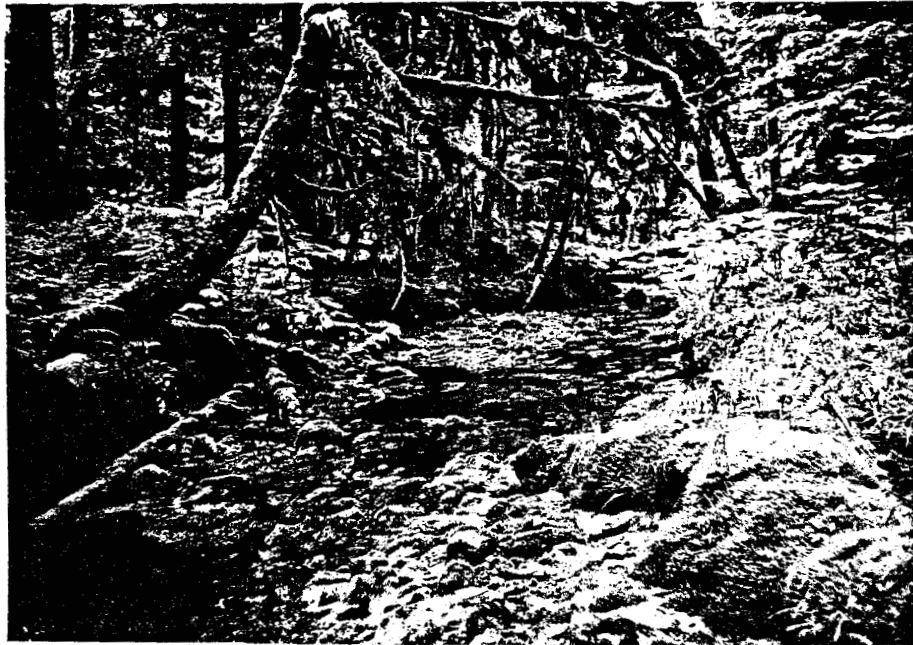
3. Habitat at the end of the survey and the end of Section 16.

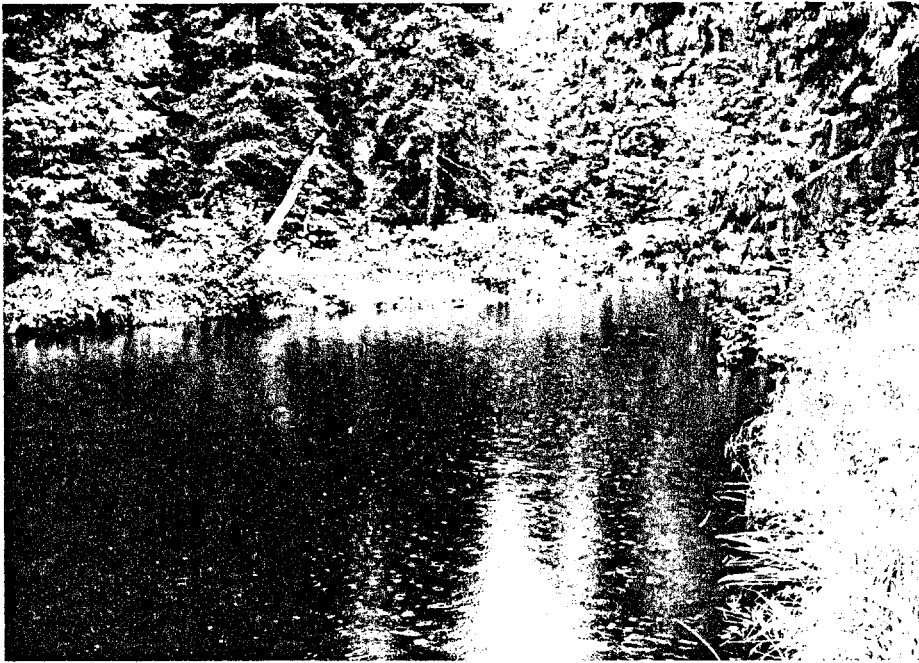
1. Section 1. Deep, slow pool area for several hundred meters.

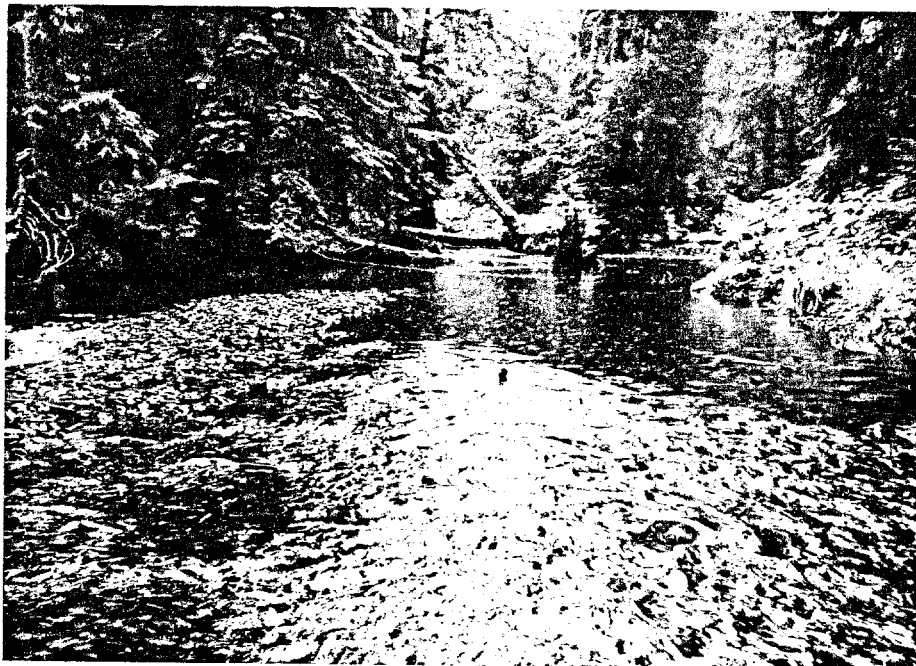
2. Good riffle area in Section 10.

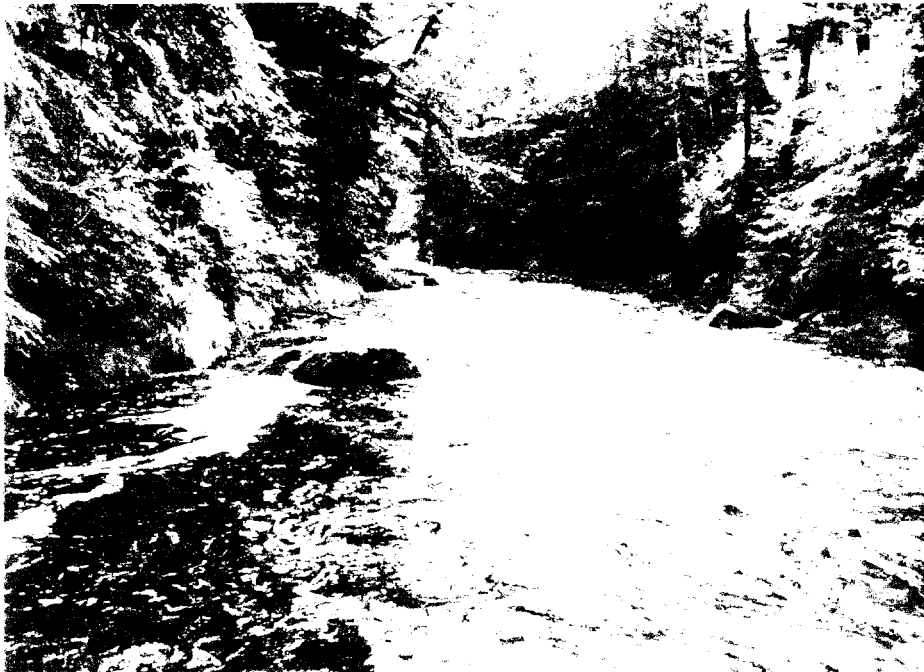
3. Section 25: Swift water with substrate consisting mostly of boulders.

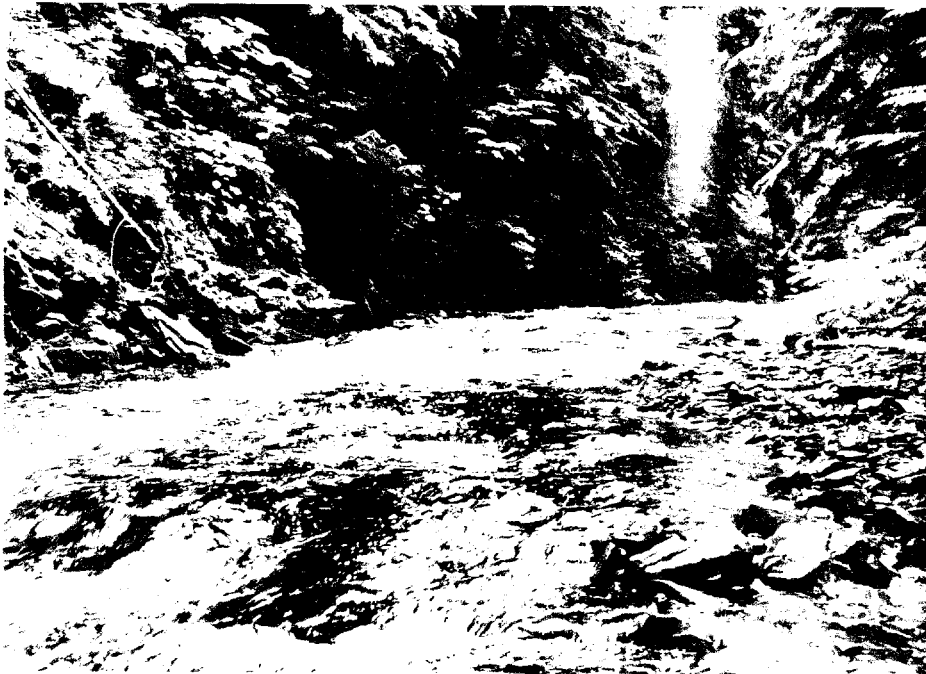
4. Typical habitat on the left fork about 1200 m. upstream from Section 25.

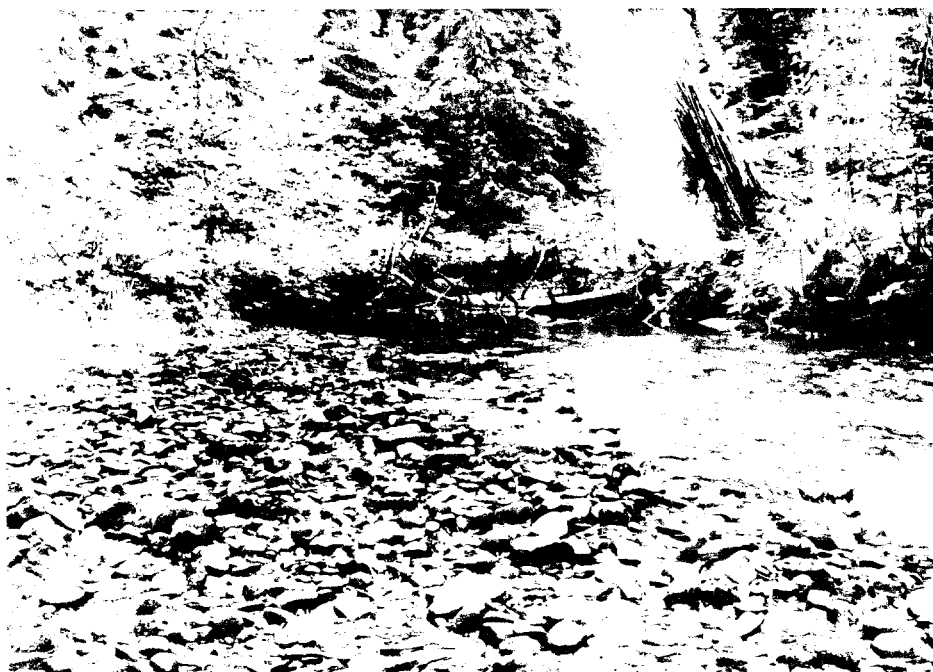
2. The substrate is mainly boulders in Section 10.

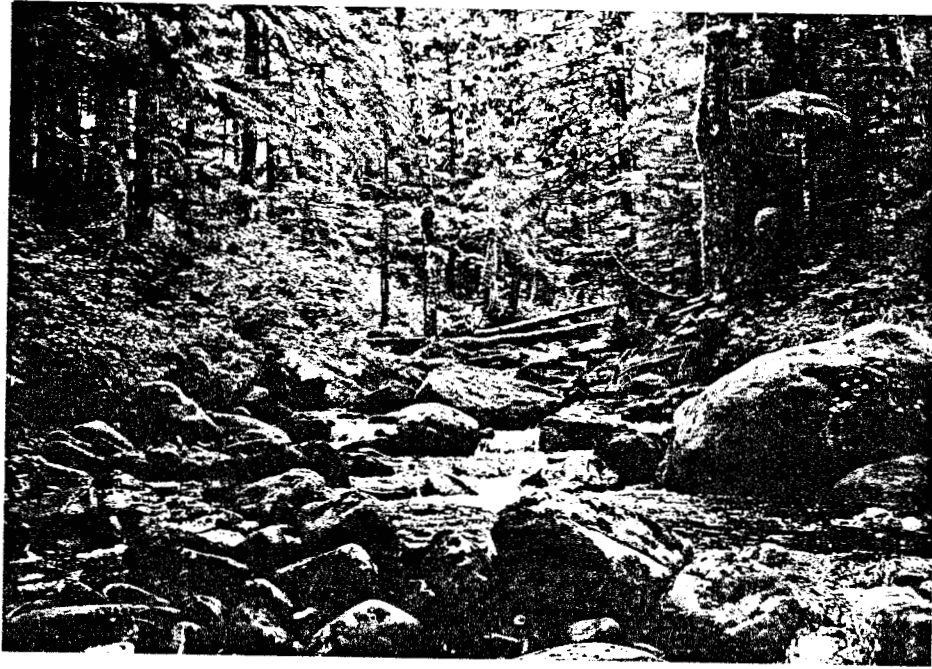
3. Section 16: The substrate is primarily large boulders.

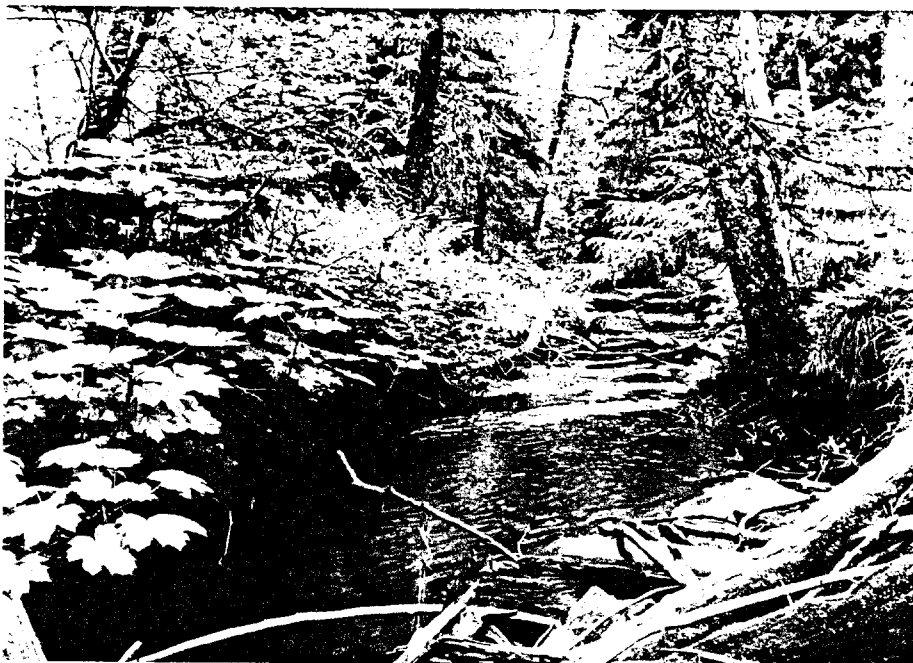
1. Good ASA in Section 6.

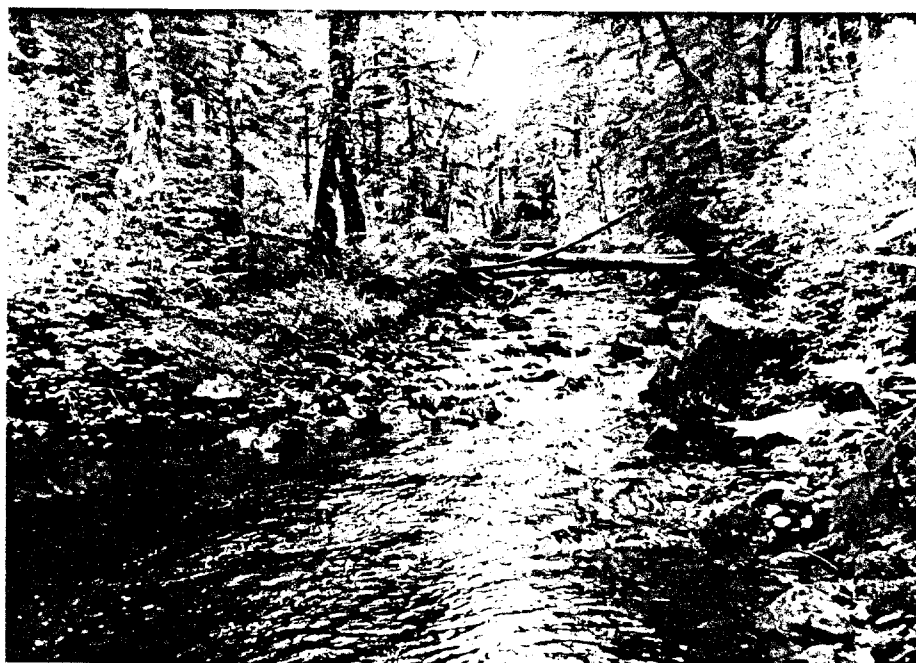
2. Section 9: Boulder substrate typical of Reach 2.

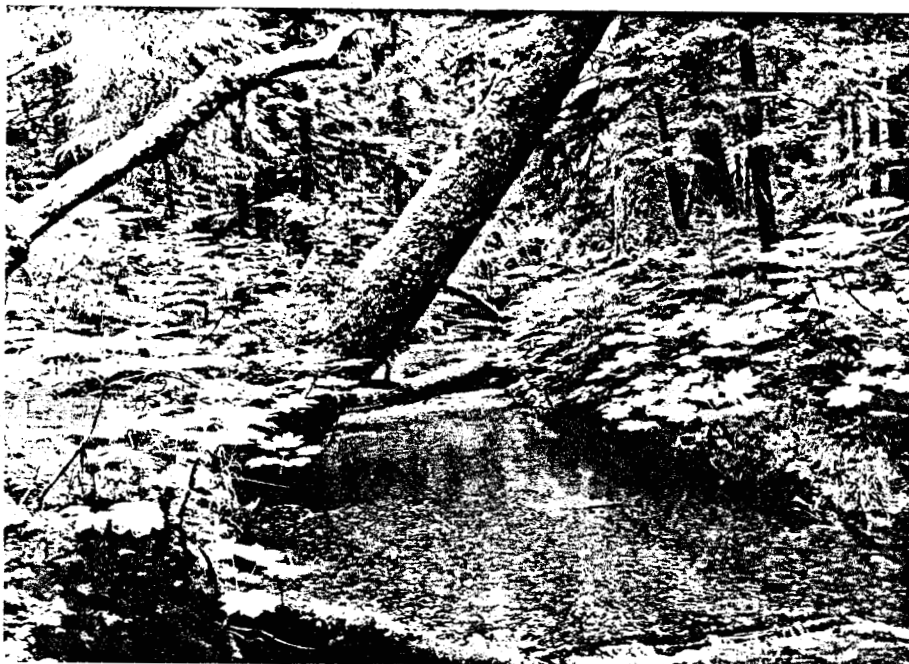
1. Excellent ASA typical of Sections 1 and 2.

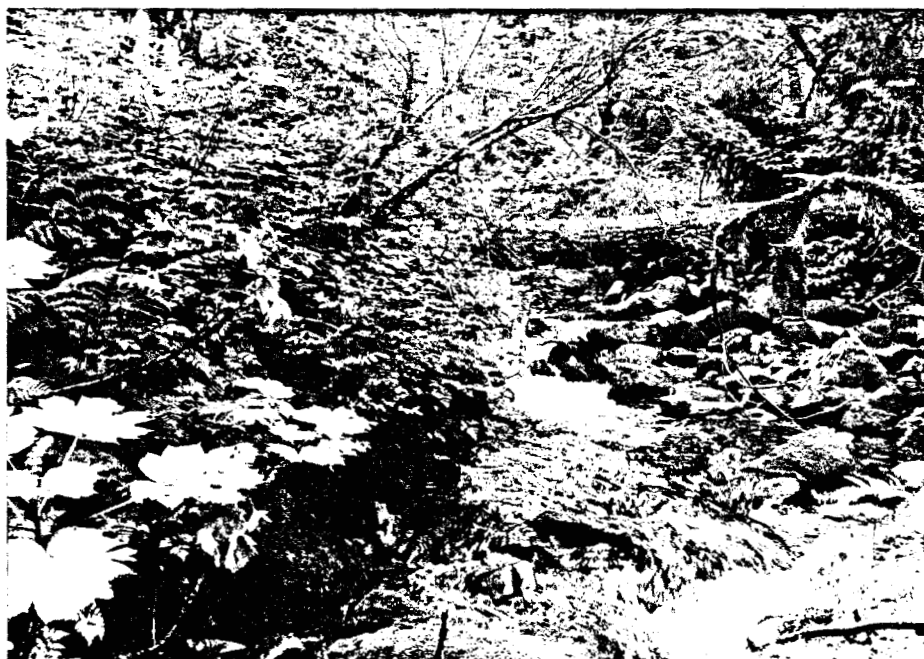
Area H is the third tributary to the south shore of Hofstad Lake. Good clean gravel provides excellent ASA for 300 m. before the substrate size and gradient begin to increase. A heavy debris load provides plenty of cover and pool area for rearing habitat. The survey was discontinued after Section 6. The gradient was 7% and increasing and the fisheries habitat quality was declining rapidly.

2. The gradient and substrate size increase at the end of Section 6.

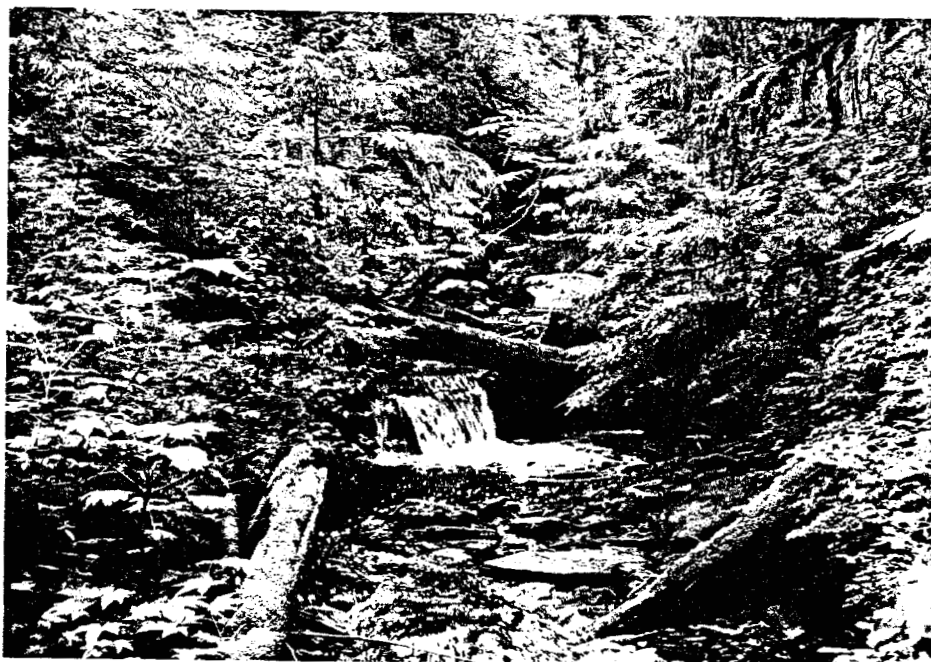
2. Typical poor habitat in Section.

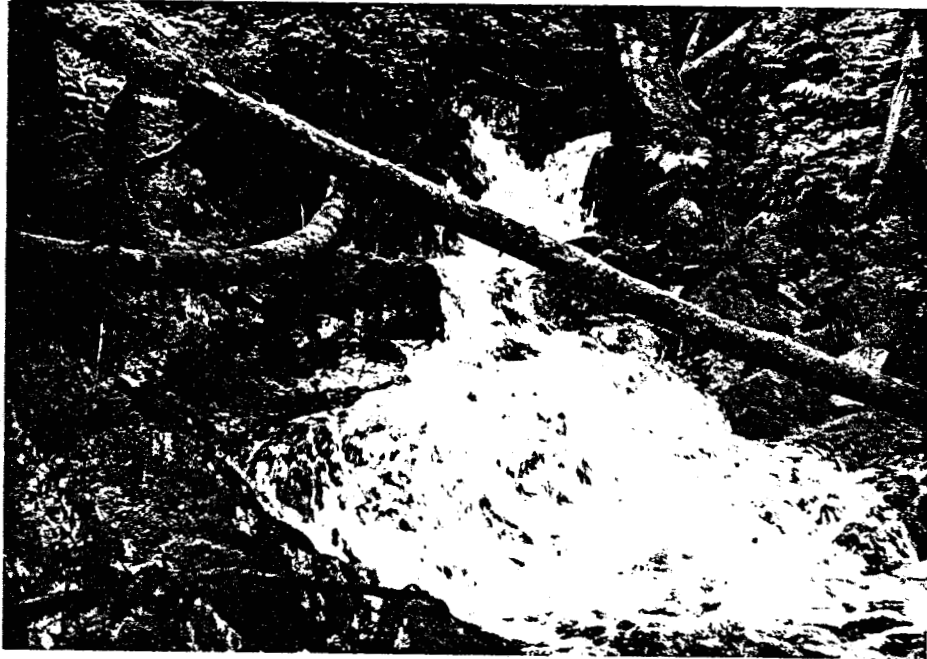
3. Potential barrier in Section 3.

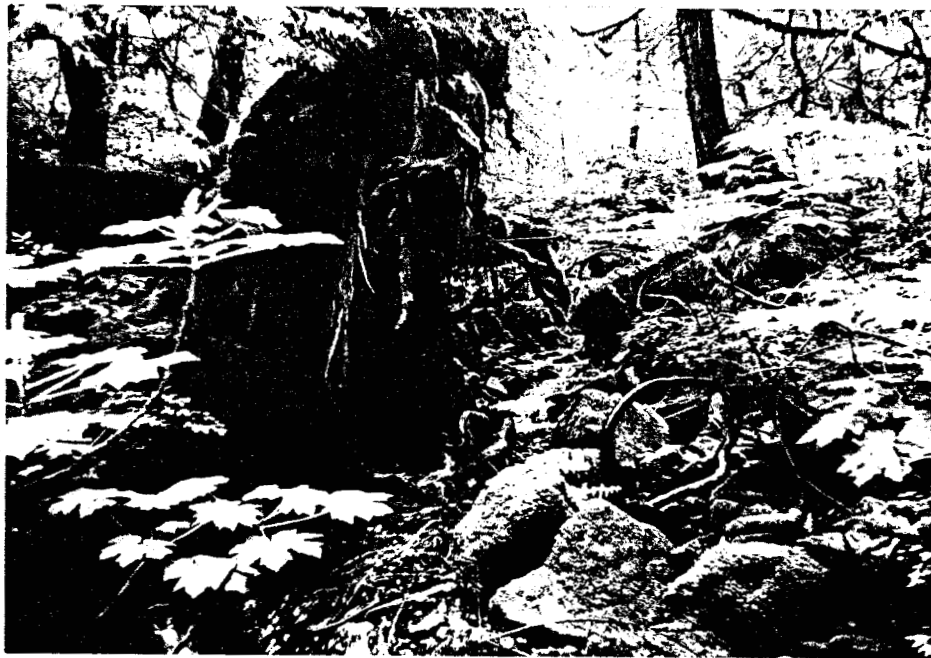
4. Section 8: Poor habitat at the end of the survey.

Section 8: The survey discontinued. There is minimal ASA or rearing habitat and no rearing fish have been observed since Section 1.

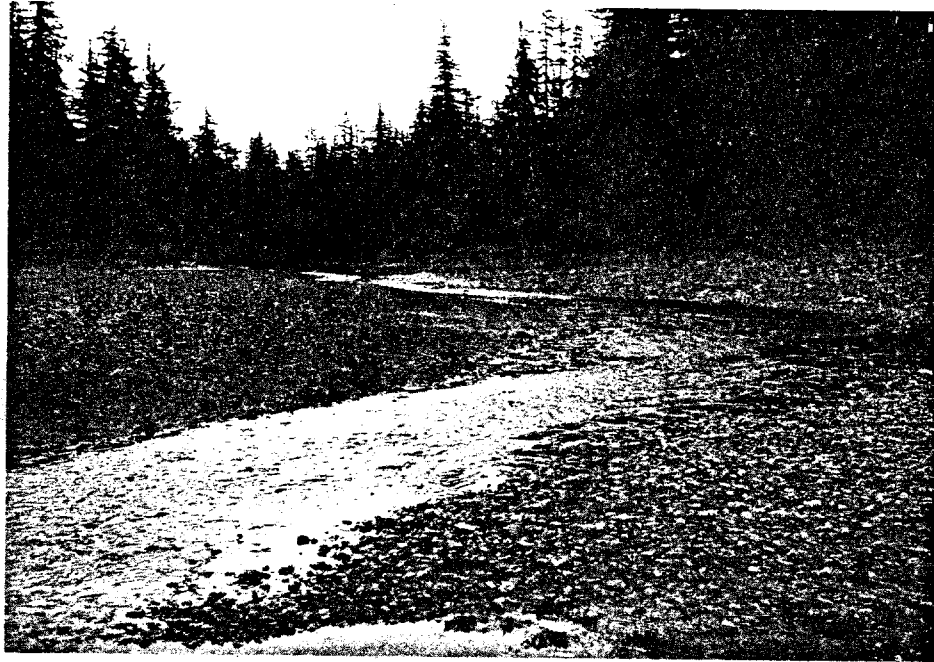
1. ITZ: Substrate covered with heavy filamentous algae.

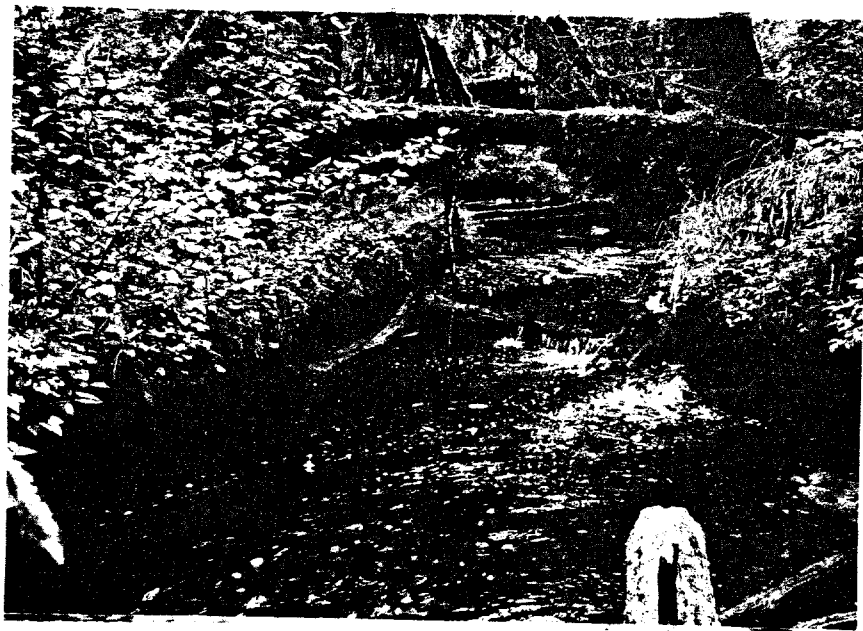
2. Habitat at the end of Section 1.

Section 1: The substrate is silty. Rearing coho were observed with regularity. Grass is growing in the middle of the stream.

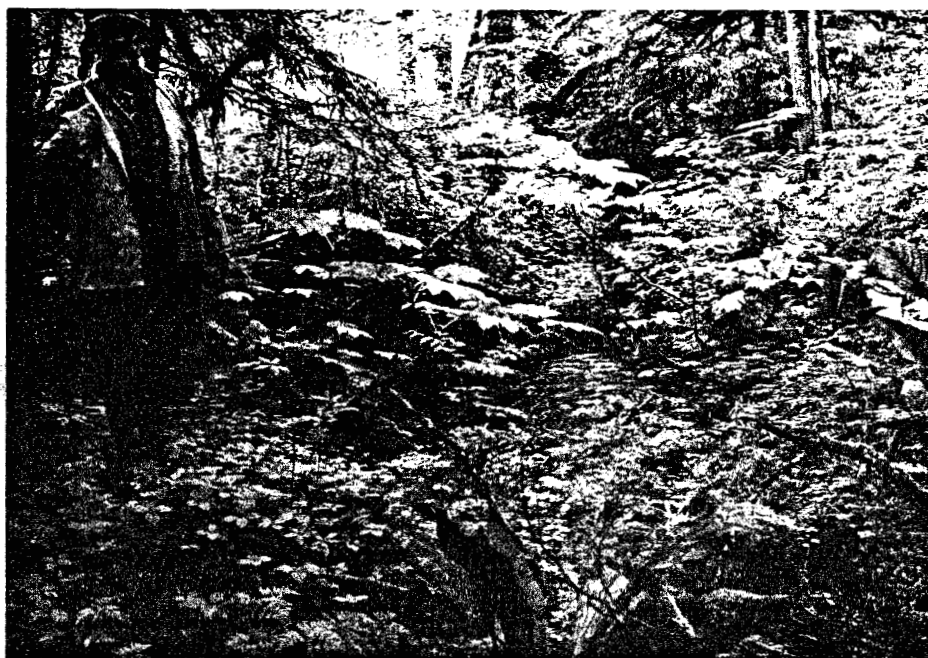
3. Section 2: Typical habitat in upper reach.

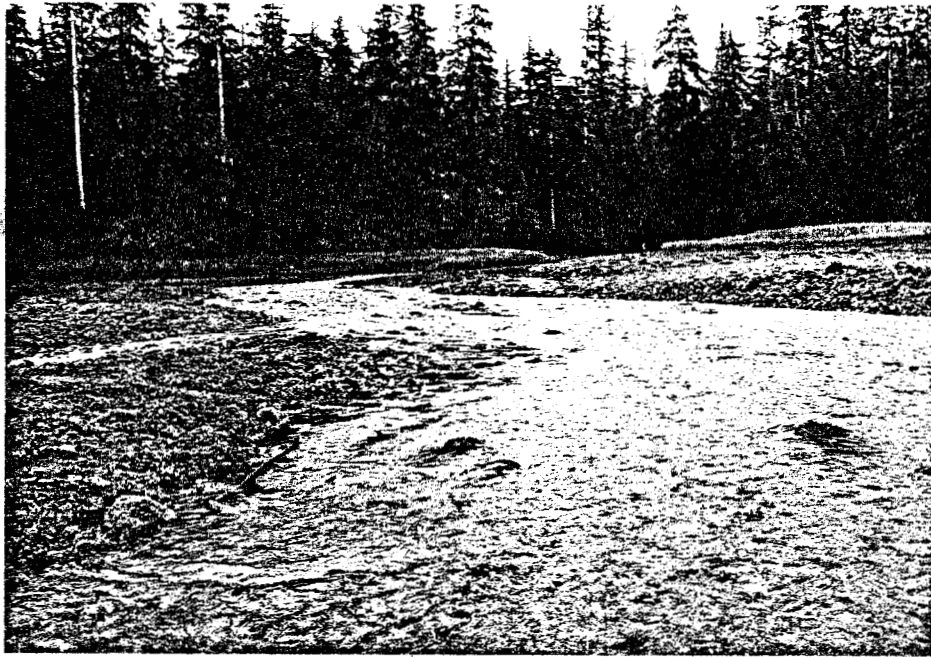
1. ITZ: The substrate is covered by dense filamentous algae.

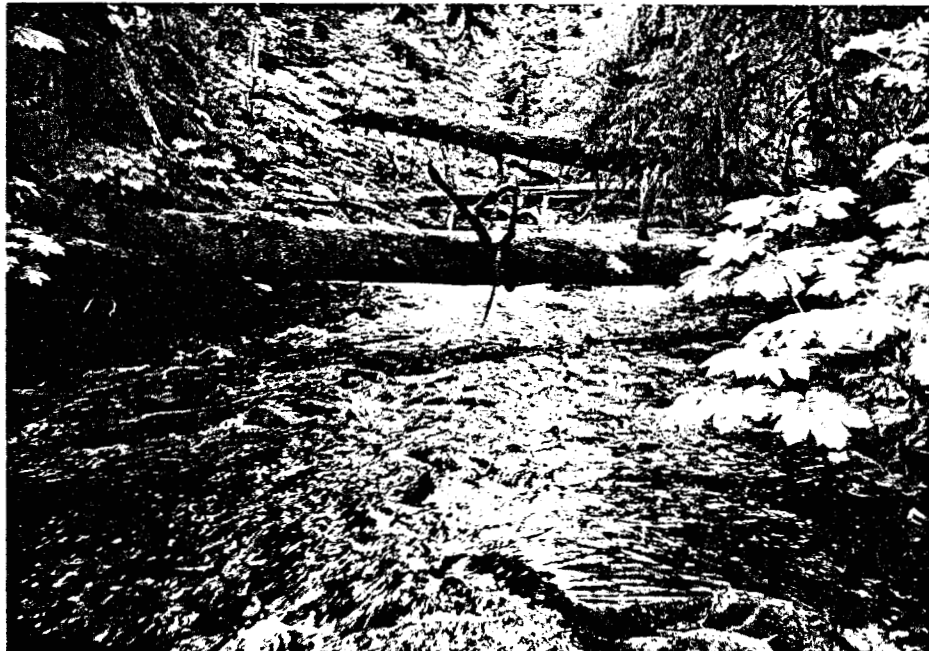
2. Typical swift nature of stream in Section 1.

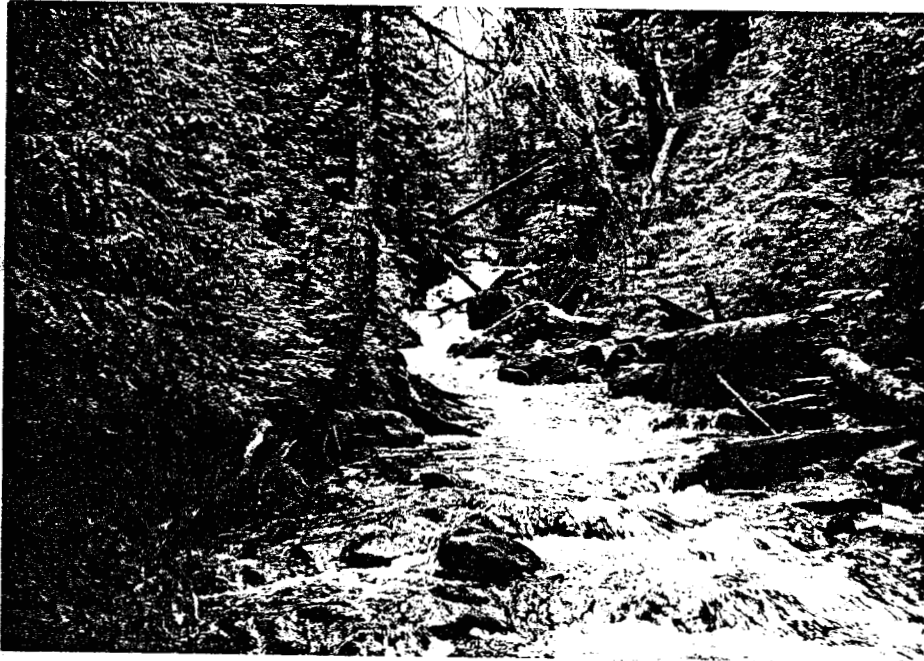
3. Series of bedrock barriers in Section 8.

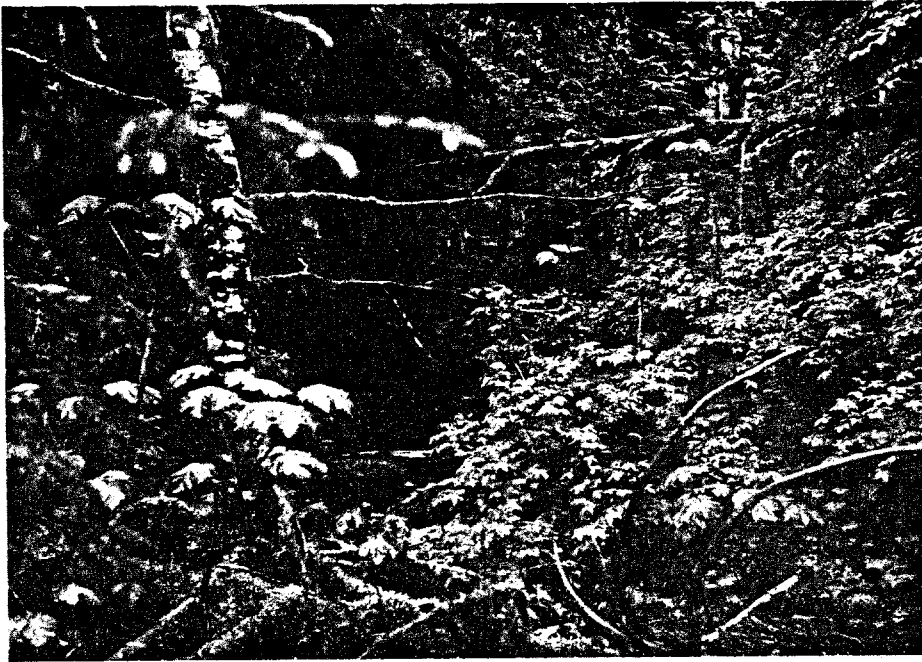
1. Habitat above the bedrock falls.

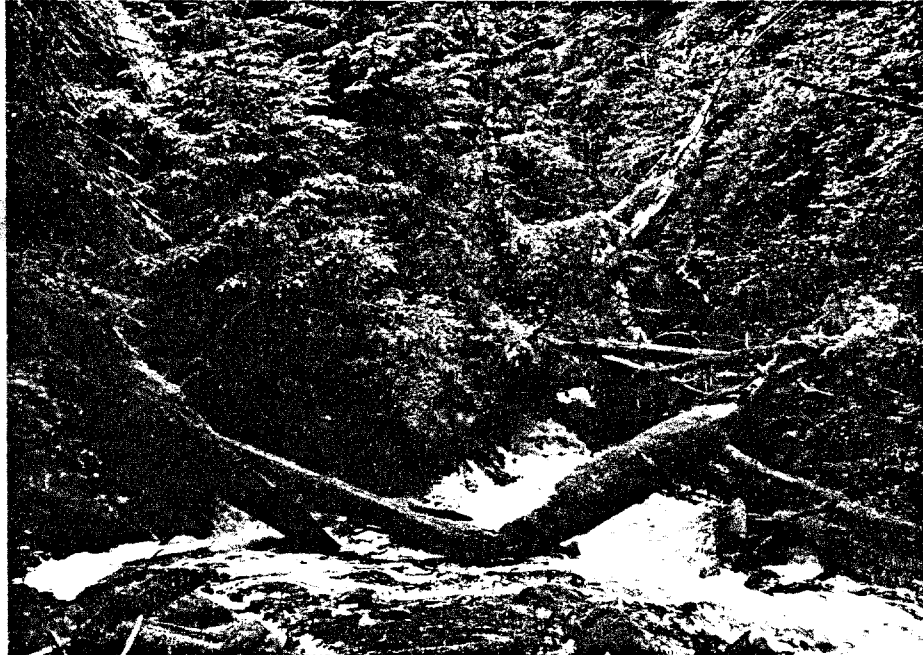
1. Habitat in Section 1. Possible debris barrier.

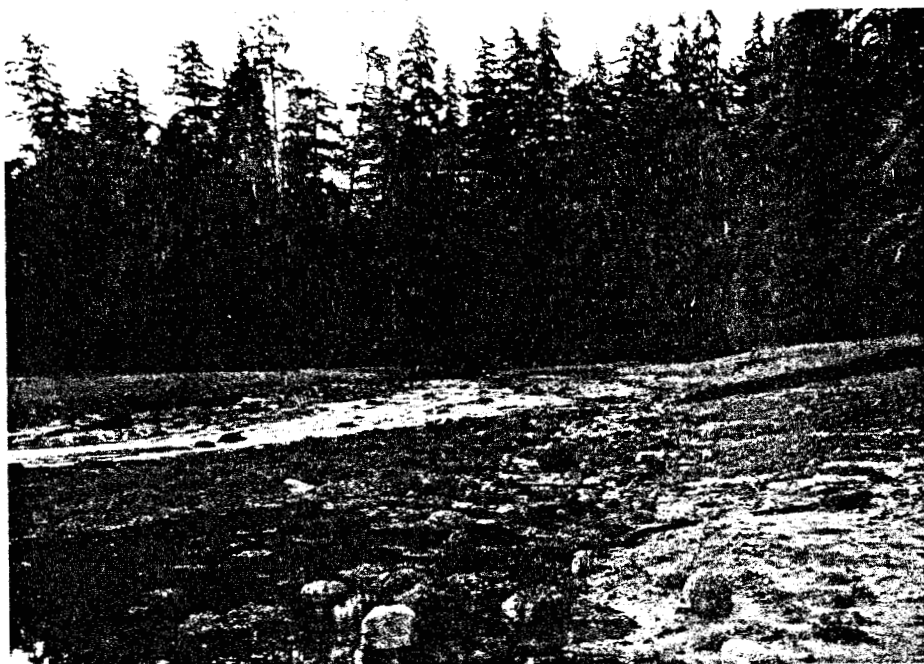
1. Poor ASA in ITZ.

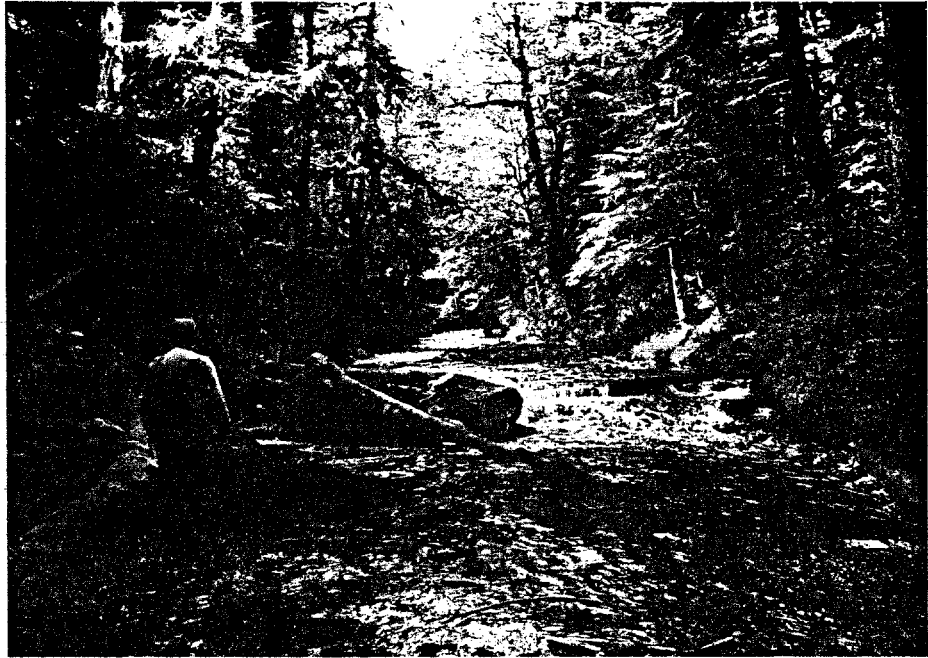
3. Section 13: Typical habitat above the falls.

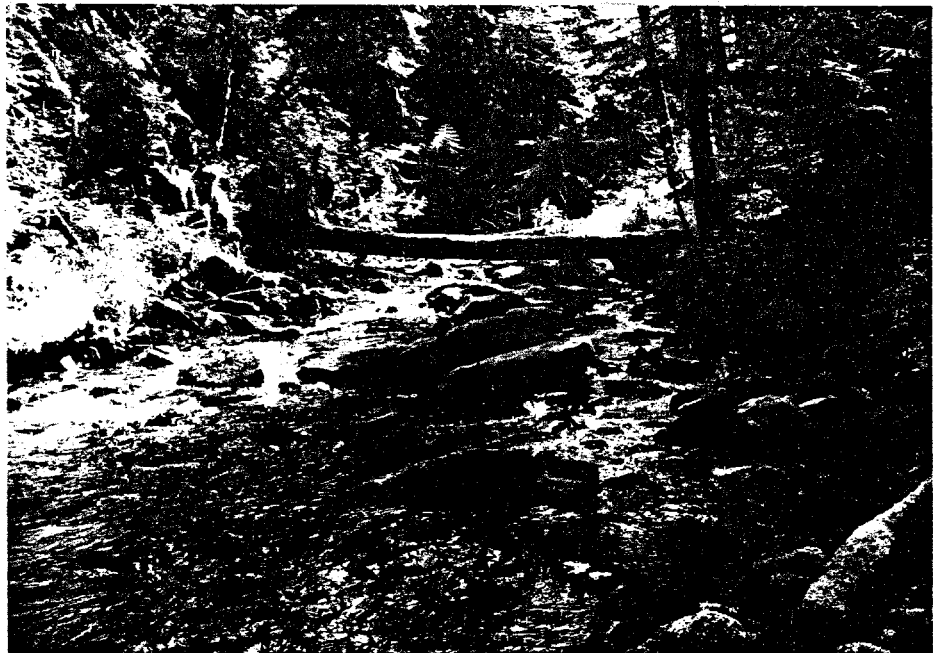
4. Habitat at the 350 ft. elevation.

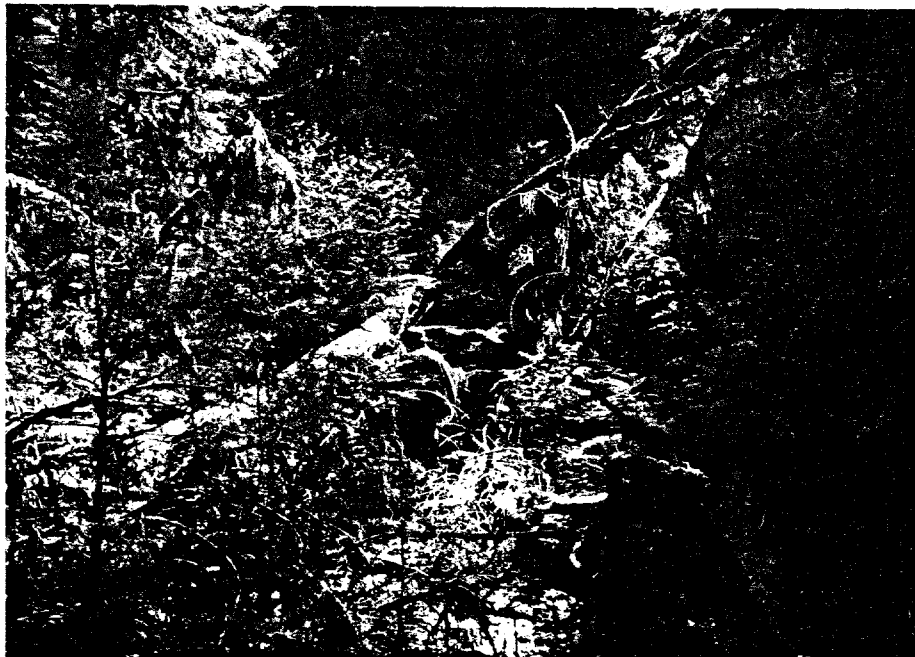
2. Unstable bank and slide in Section 5
Typical of reach 1.

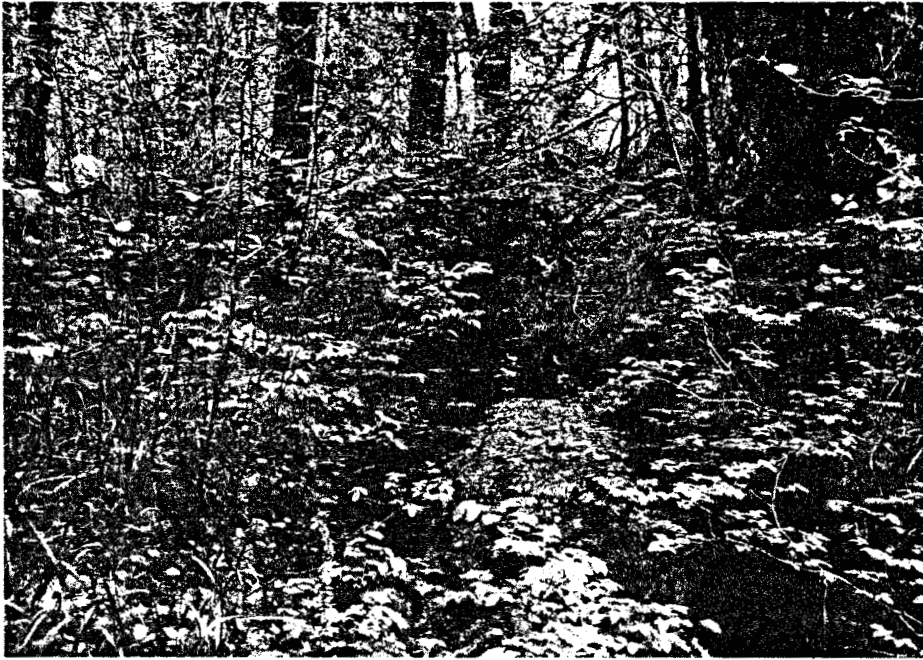
3. Typical habitat at end of survey - Section 11.

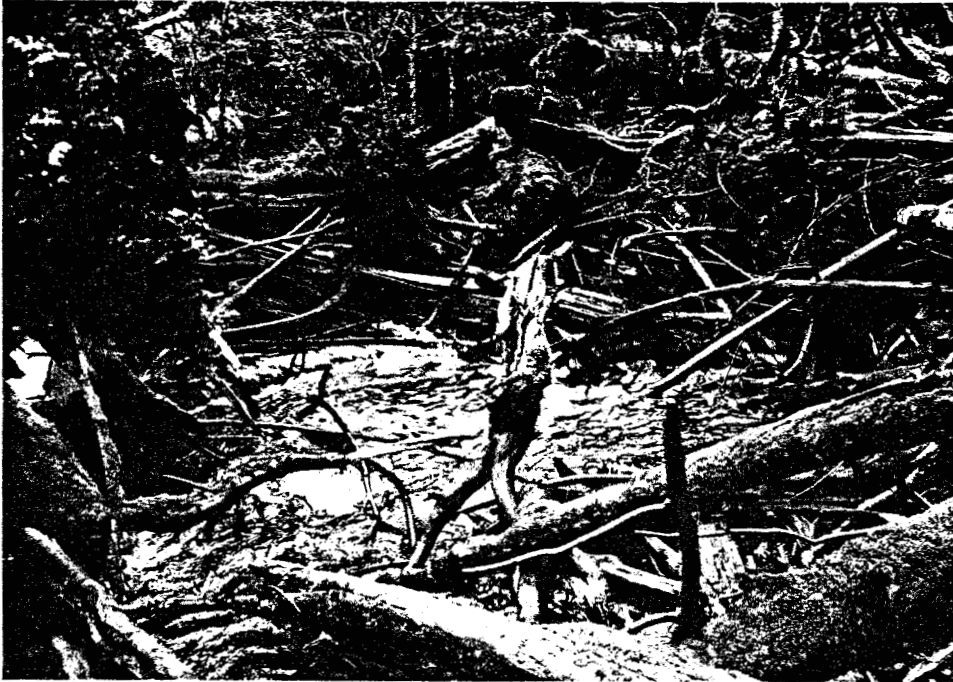
3. Downstream view of debris jam in Section 16.

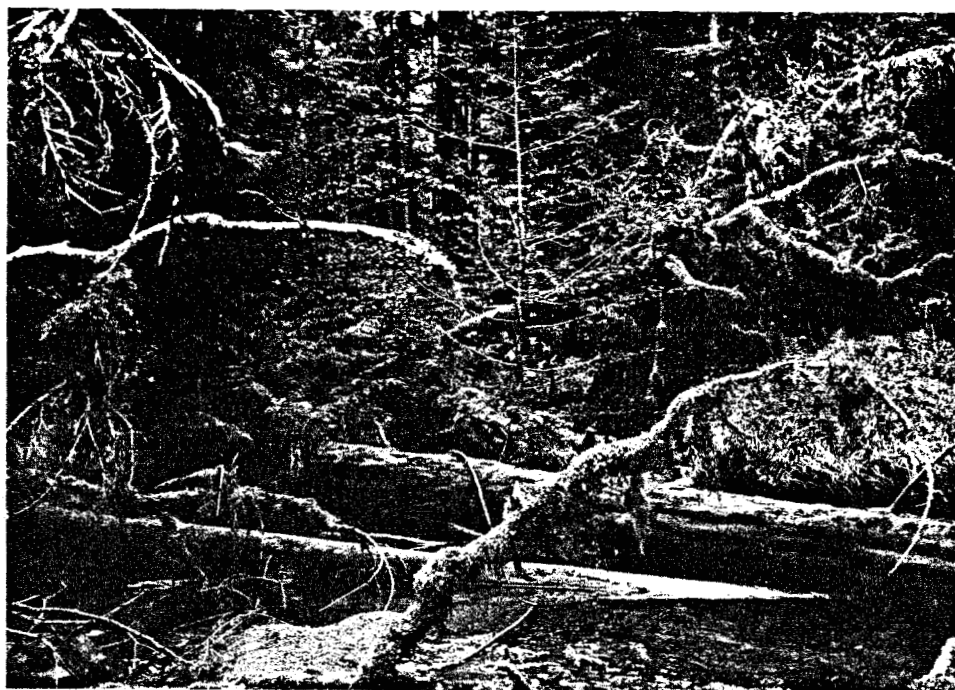
5. Section 1: ASA substrate contains a heavy sand load.

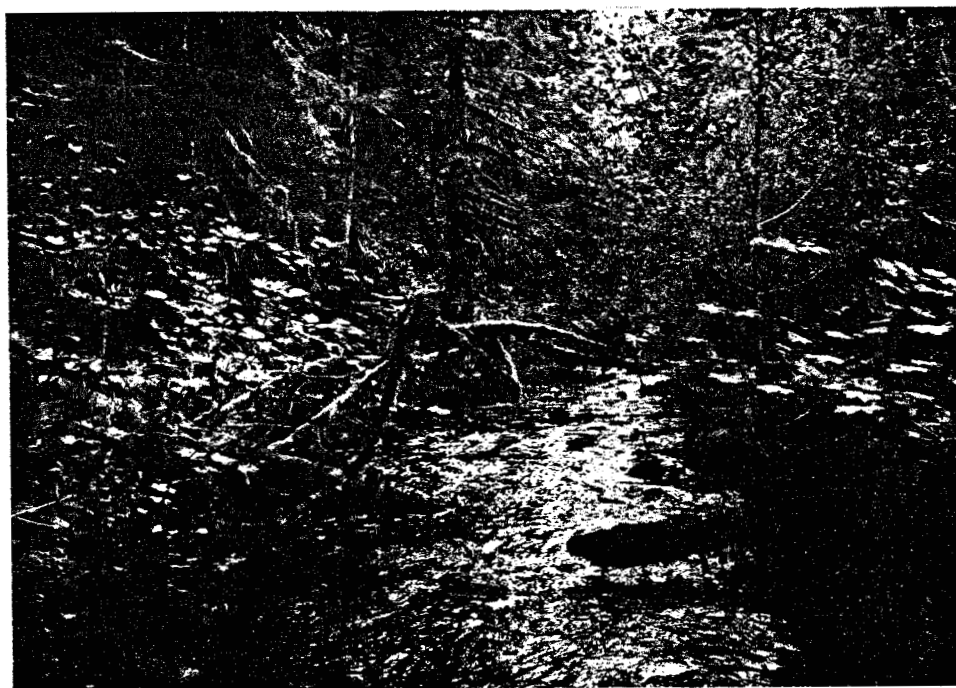
6. Area C: Section 1: Typical habitat in Area C.

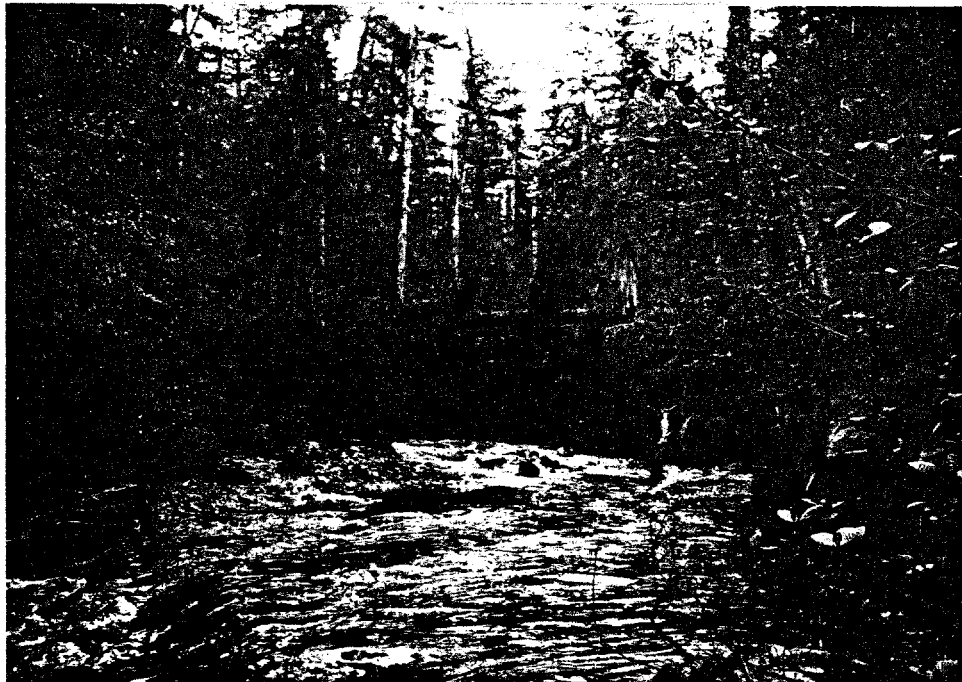
4. Increasing gradient and substrate size at end of survey
Section 20.

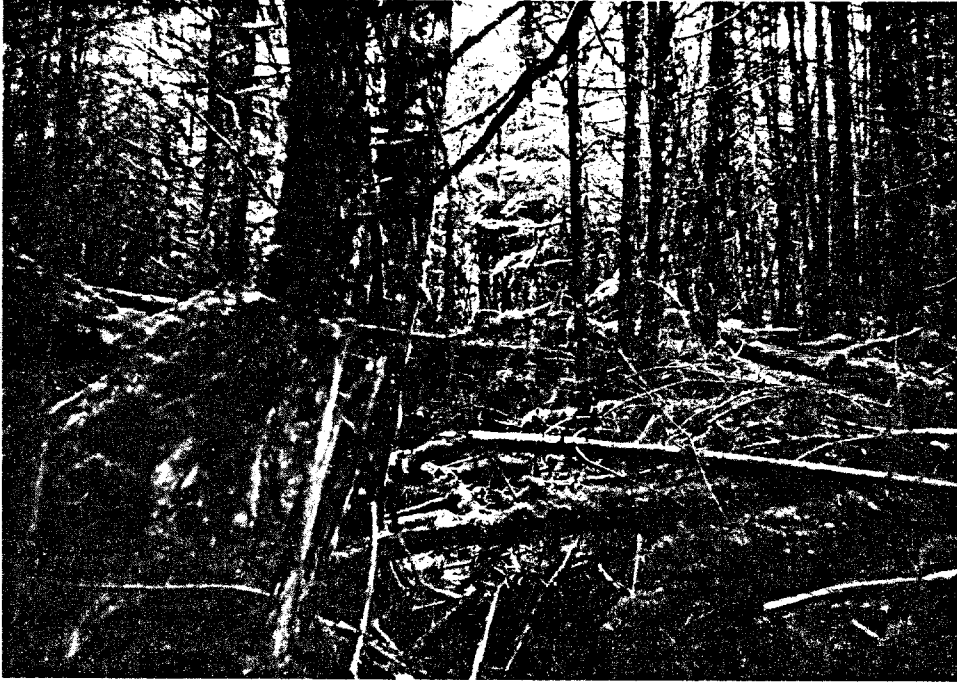
1. Typical Habitat

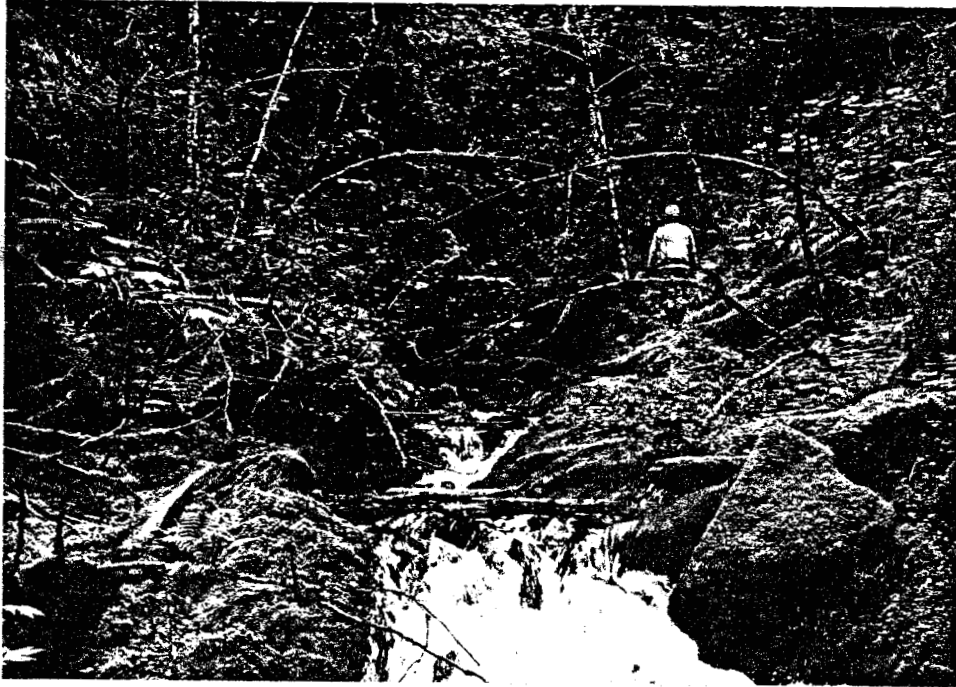
1. Habitat 50 m. from the ITZ.

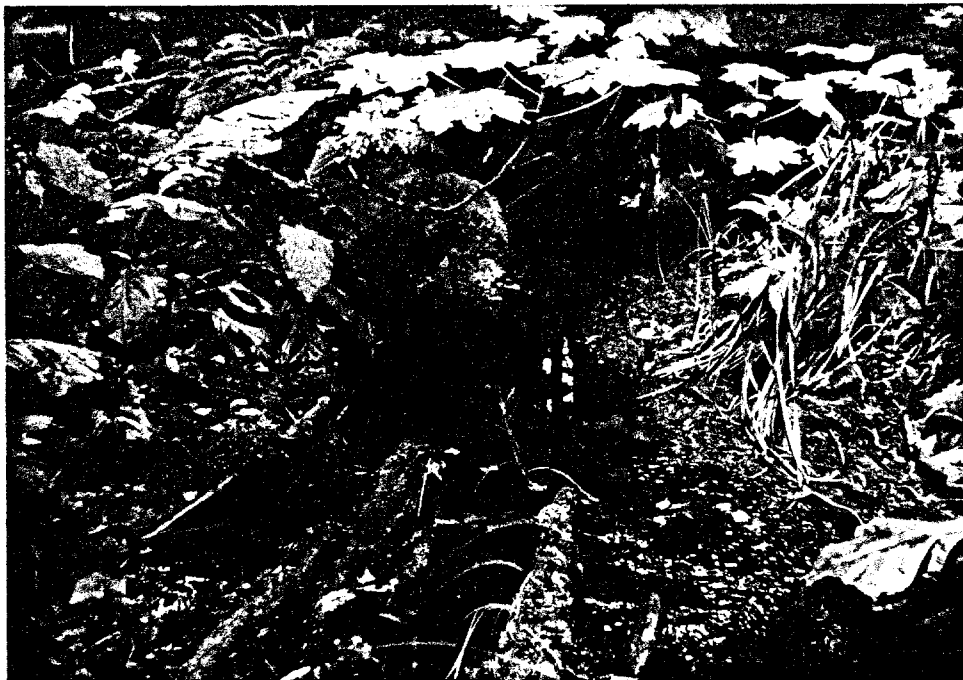
2. Typical habitat. Rearing fish were moderately abundant.

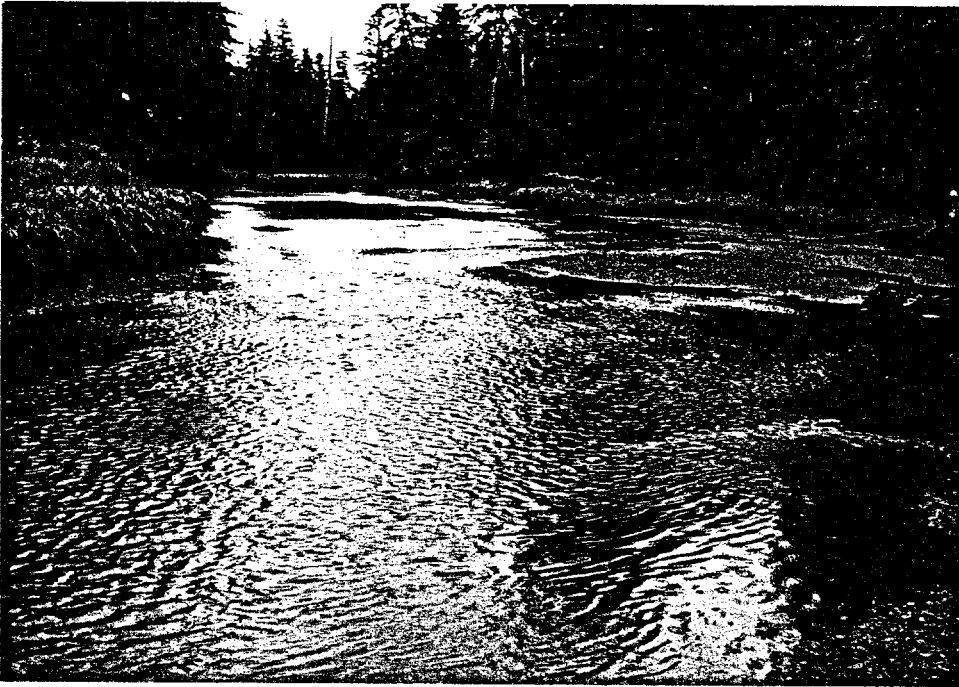
1. Section #1

Section 1: The substrate contains interstitial sand and the ASA is not high quality. A relatively large amount of sand was observed throughout the survey area. There also is little over for the rearing habitat for the first several Sections.

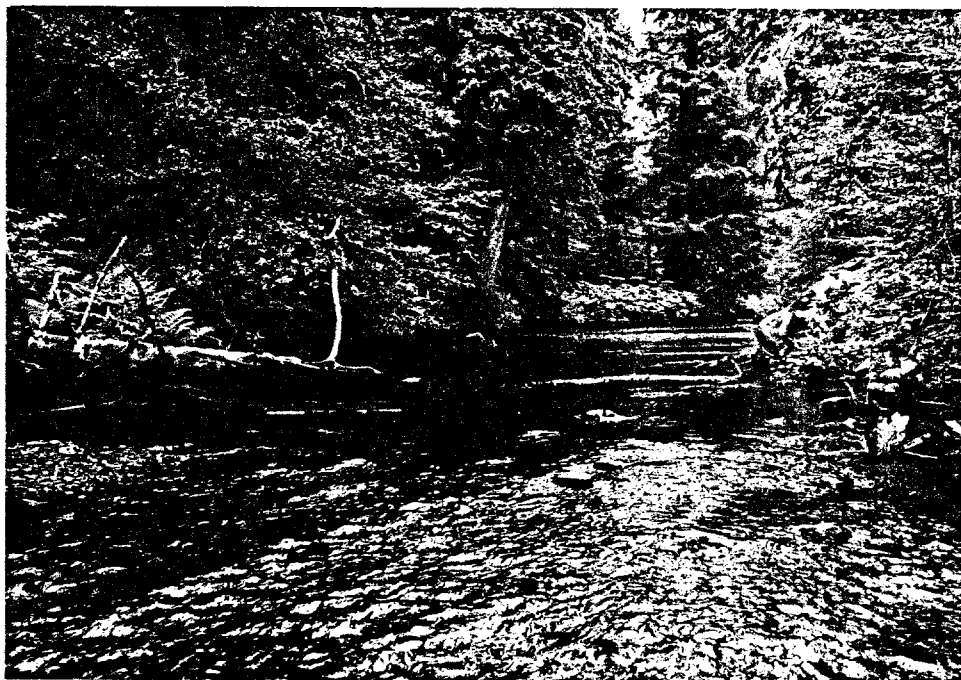
4. Section 48: Excellent ASA typical of Reach 5. Rearing coho were abundant also.
